# Cable diagnostic in MV underground cable networks

## Theoretical background and practical application

- VLF testing
- tan delta loss factor measurement
- Partial discharge localization and measurement

Author: Tobias Neier, Ing., MBA

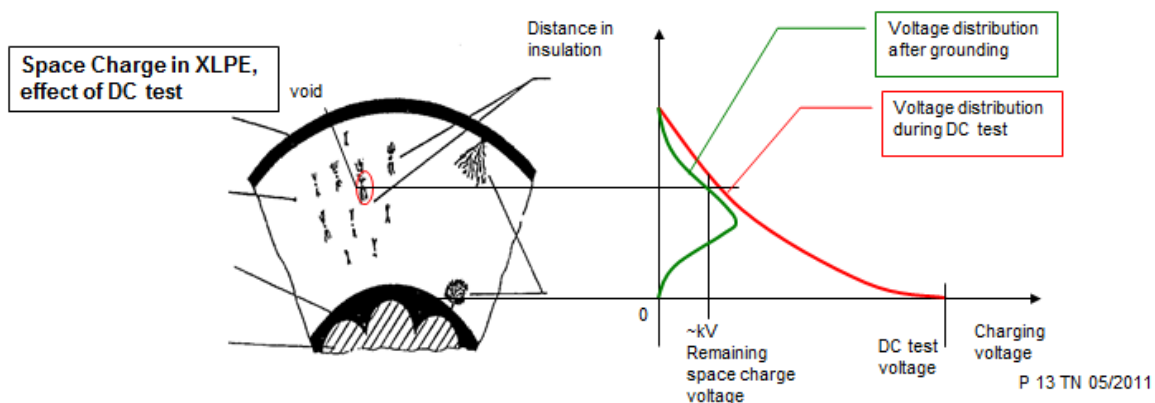
Figure 2 Space Charges in voids of XLPE during DC test [5]

Cables that are switched on after a successful DC test may face that those locations with voids will receive overstress and might fail soon after the switching on sequence.

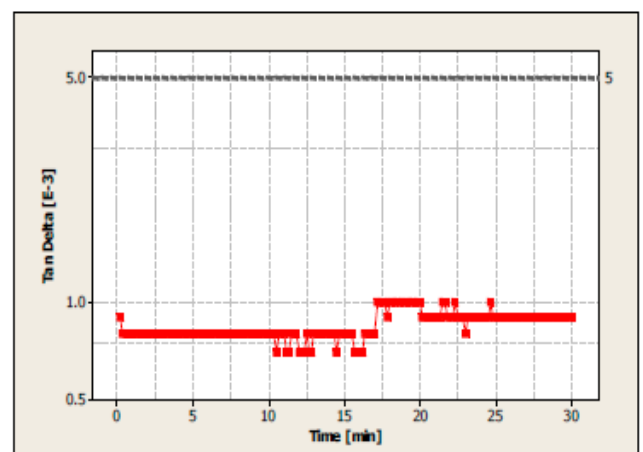
**Figure 4: Tan delta Monitored Withstand Data on service aged XLPE cables**

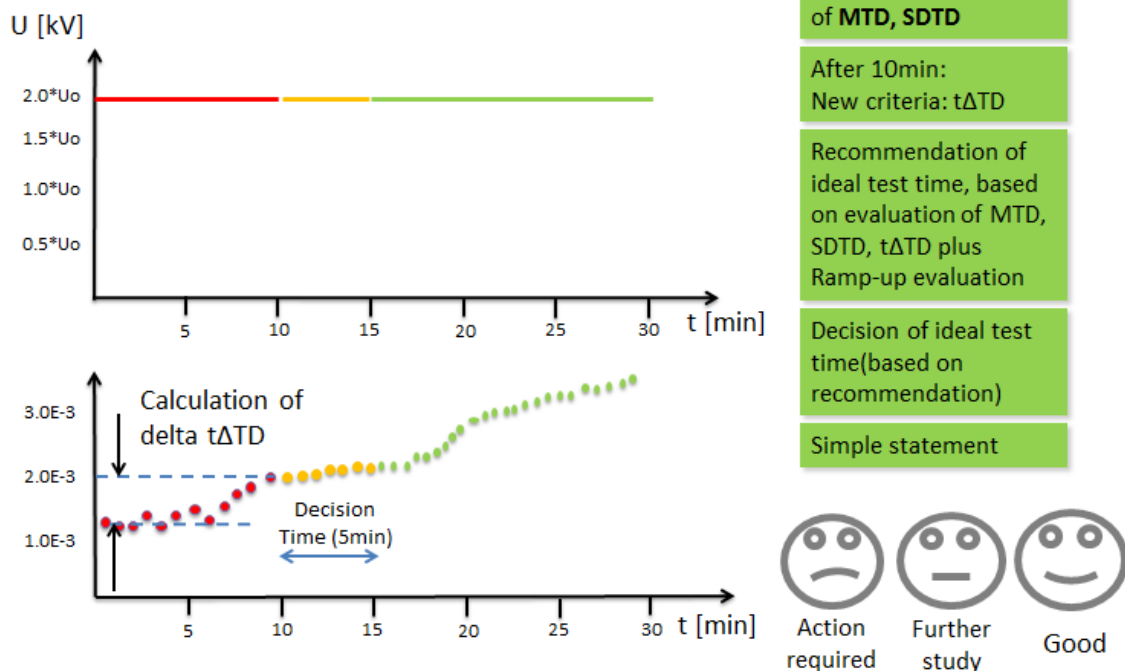
Figure 18, illustration of MWT / Hold stage

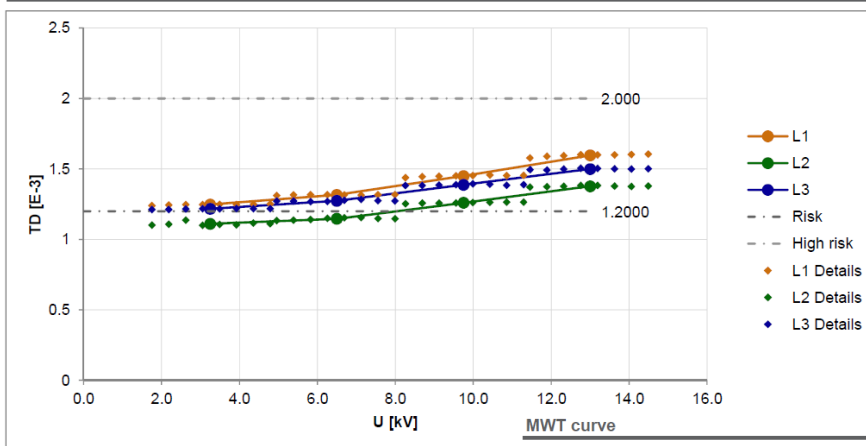
Figure 19, Ref. 8438CM, Ramp-up, XLPE stable condition

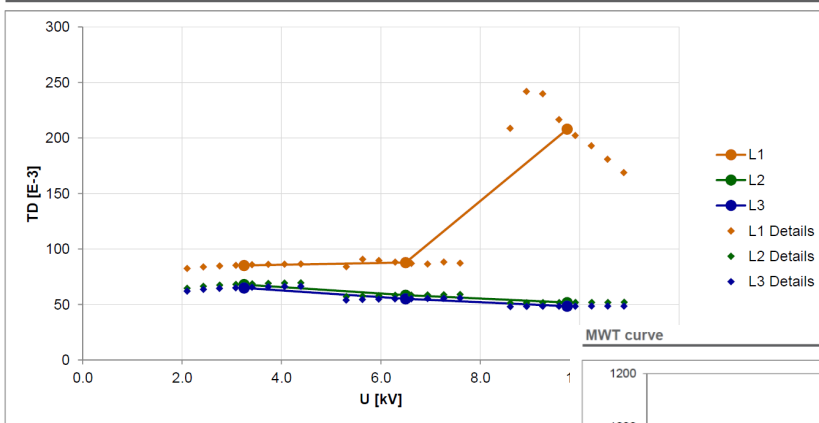
Figure 23; Ref. 3730-31, Ramp-up, tracking & moisture in L1, decreasing DTD, aged PILC

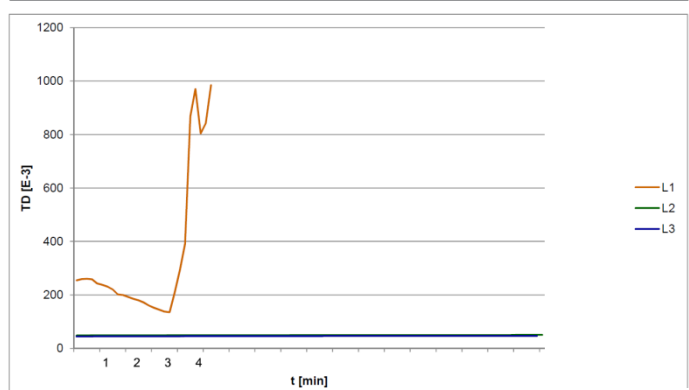
Figure 24; Ref. 3730-31, MWT / Hold phase, joint breakdown after 4 minutes

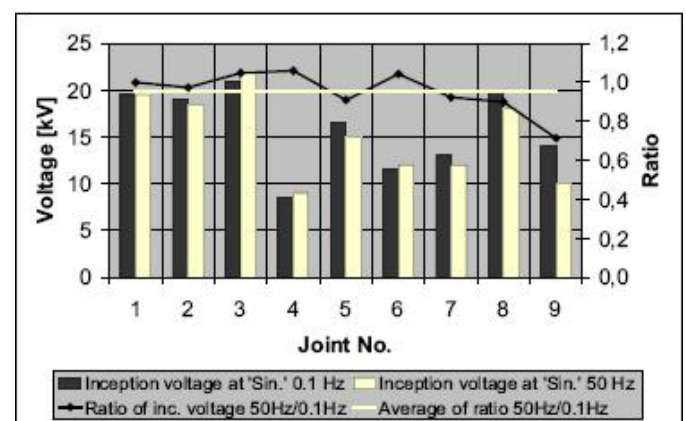
Figure 28 Partial discharge inception voltage in comparison with HV source [16]

Results, based on sinusoidal waveform are shown in Figure 28. Quite similar results can be found in respect of PDIV. The **ratio is varying in all cases with less than 10%**. As we can see, also at higher voltage levels up to 80kV, the VLF is showing comparative results. Very similar PD patterns at higher sinusoidal voltage levels on different artificial joint faults on a 110 kV XLPE cable have been identified. [16]

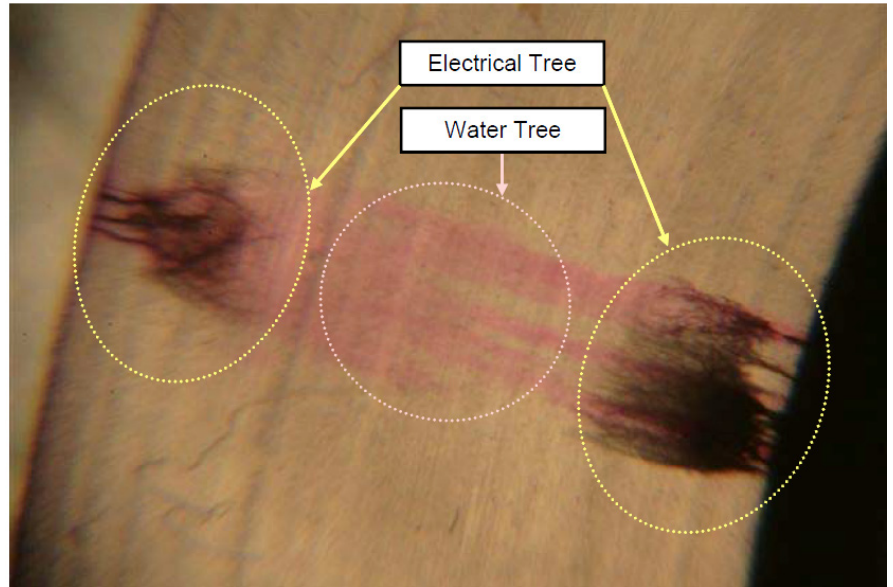
Figure 39 Photo of actual water tree and electrical tree after dissection (XLPE cross section)

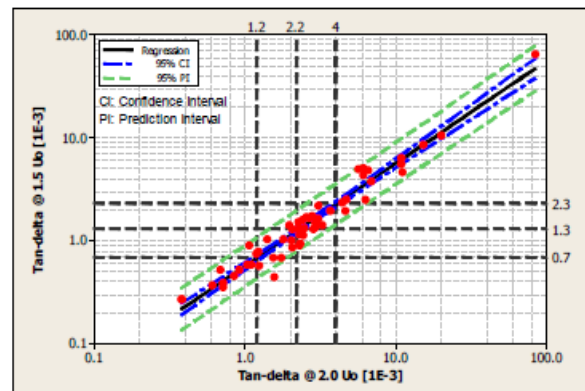
**Figure 12: Correlation between  $Tan \delta$  measurements from field testing at 2.0  $U_0$  and 1.5  $U_0$  for modified diagnostic criteria**

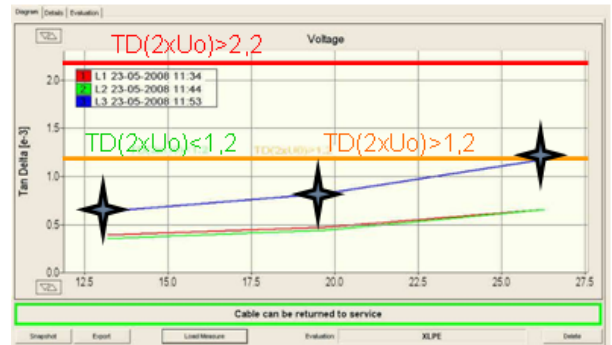
TD graph: Cable in good condition,  $< 1.2 \cdot 10^{-2}$  @  $2 U_0$ , IEEE

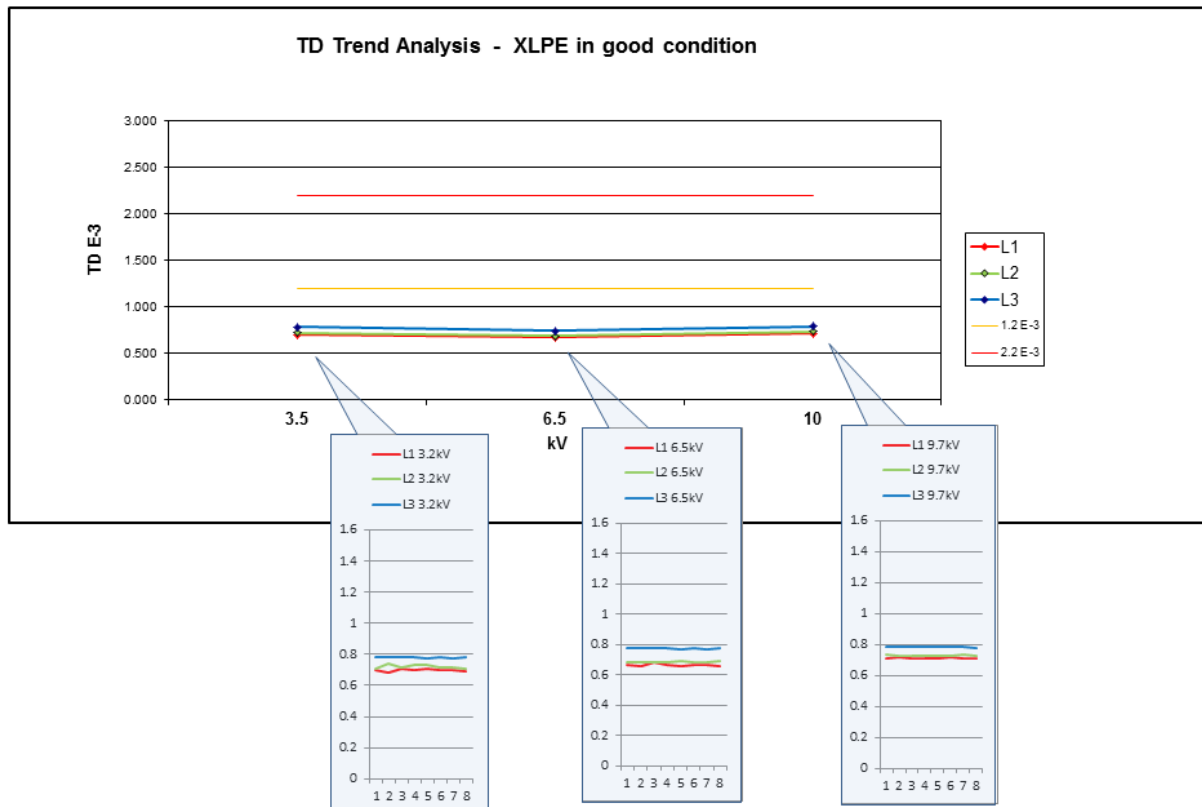
Figure 49 TD trend pattern - XLPE in good condition [19]

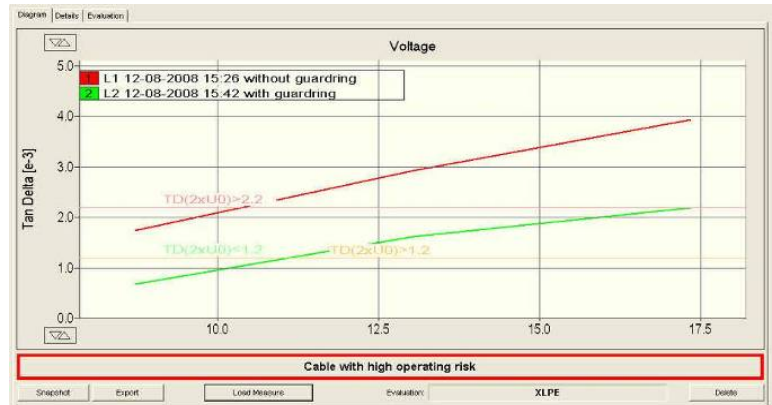
Figure 62 direct comparison of the TD value with guard ring application and without guard ring application

The shown TD graph shows an example, where the termination had been cleaned properly. The relative humidity was very high. Only by means of the guard ring application, the real loss factor of the cable could be measured.

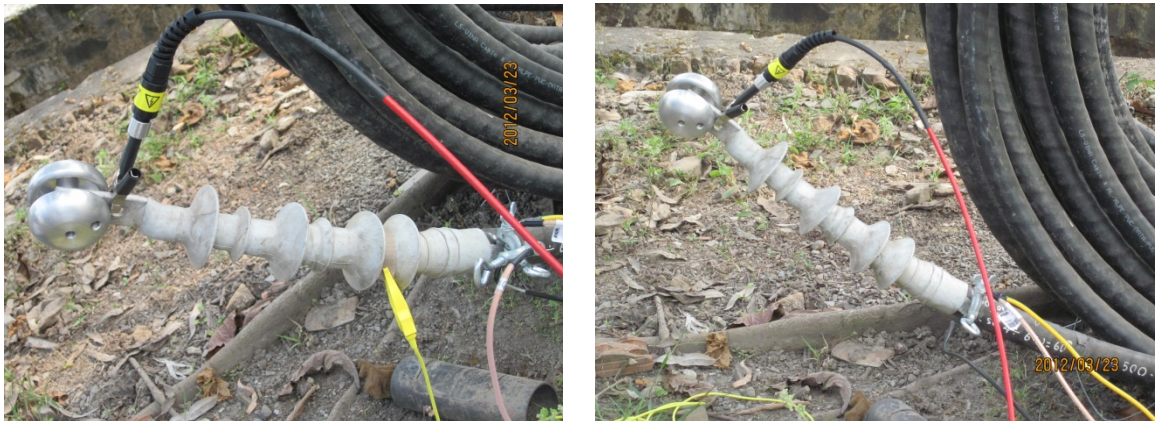
Figure 63, connection arrangement with guard ring and corona hoods (left), without guard ring (right); relative humidity 80%, 30°C

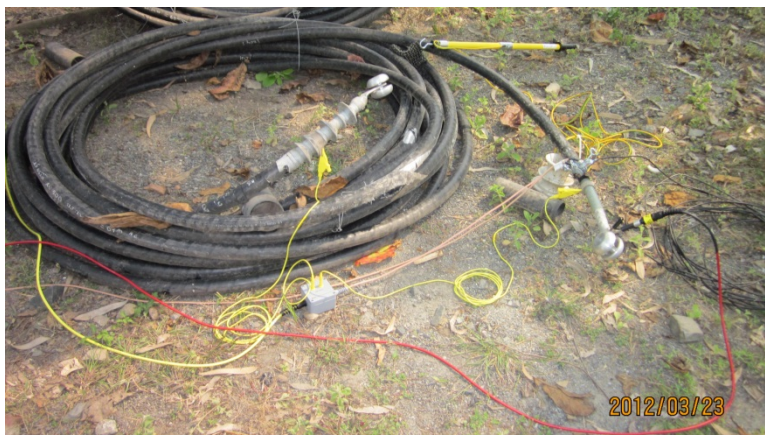
Figure 64, connection arrangement with guard ring and corona hoods, VSE box, Frida TD connection

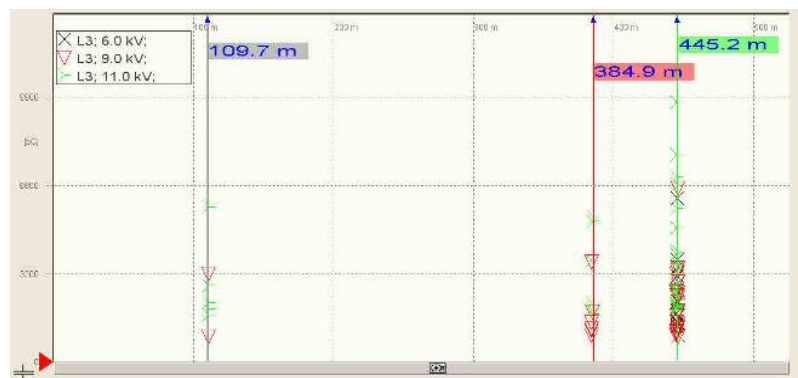
Figure 74 PD Localization Graph of a XLPE cable with 3 joints with PD activity

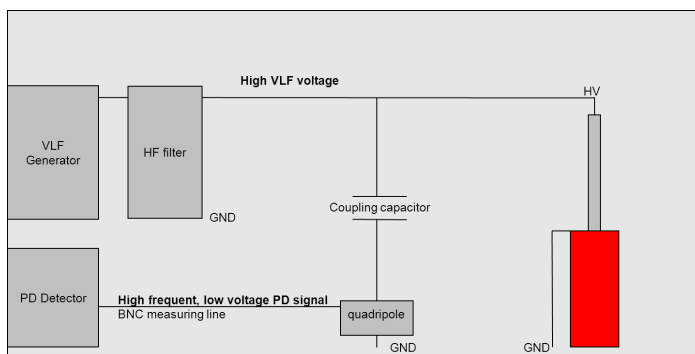
Figure 76 Test setup of BAUR VLF PD System

Partial discharges inside the cables cause a short term breakdown of the cable insulation. The thereby caused pulse-shaped recharging current is detected at the coupling capacitor over the measurement unit (quadripole) - in parallel to the cable - and converts it into a equivalent voltage signal. This voltage signal is then recorded by the partial discharge detection system and monitored as an impulse an on the monitor.

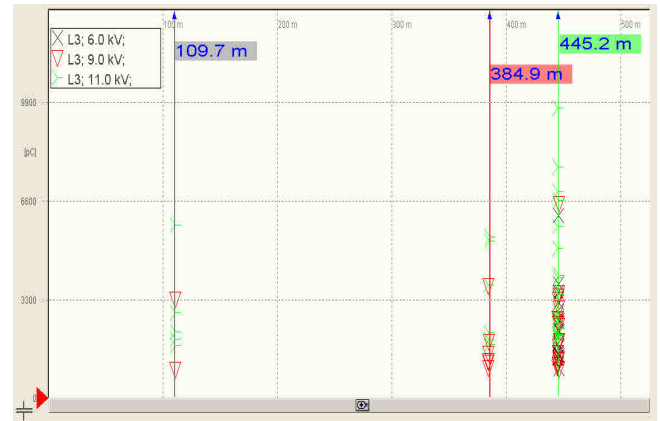
Figure 90 PD graph of XLPE cable with PD activity concentrated at 3 joints

In XLPE and EPR cables PD activities mainly occur in cable accessories. PD in the XLPE insulation itself can be detected very rarely. If PD occurs in the XLPE insulation (electrical treeing) the cable will fail within a few days or maximum weeks. Therefore it is very seldom a PD Diagnostic is carried out exactly within this short time period. Another reason for PD activity in the XLPE cable section could originate to severe damages of the outer protective sheath.

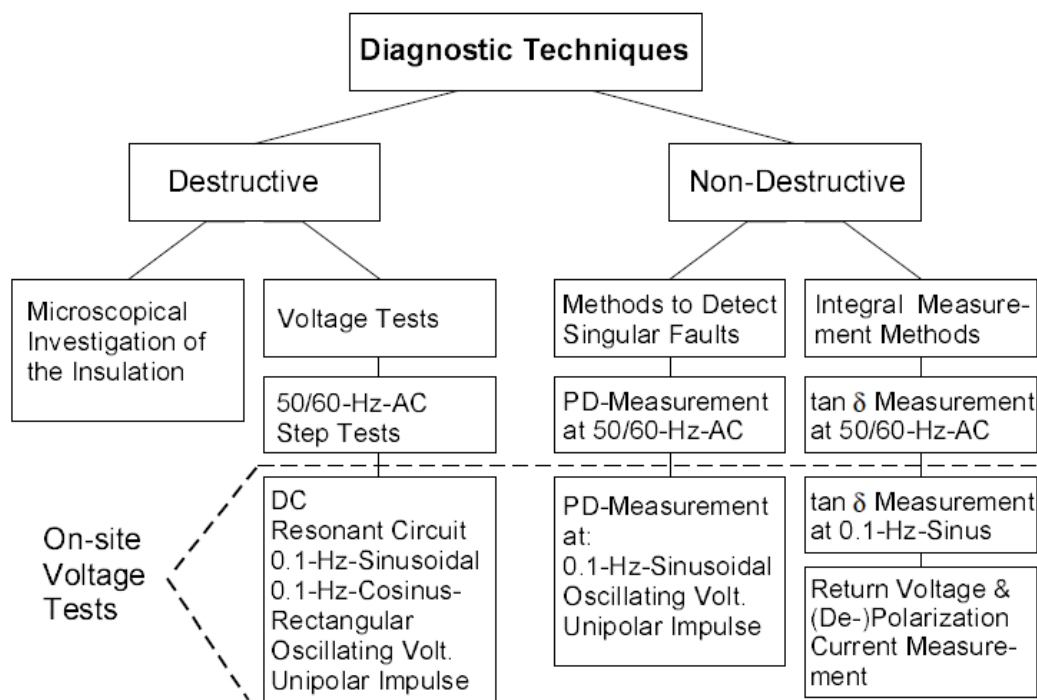
Figure 92 Survey of diagnostic techniques [24]

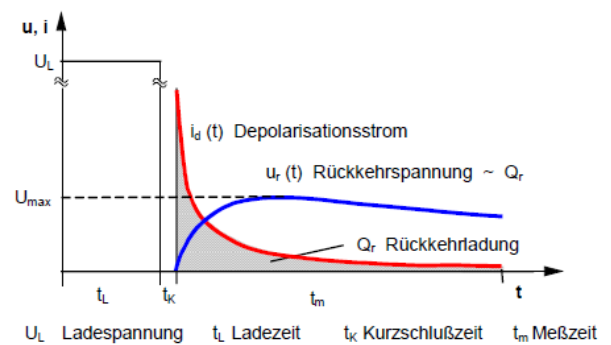
Bild 5: Prinzip ausgewählter zeitbereichsbasierter Diagnoseverfahren

Figure 94 (picture 5 [24] ), prinzipial of selected time-range based diagnostic method

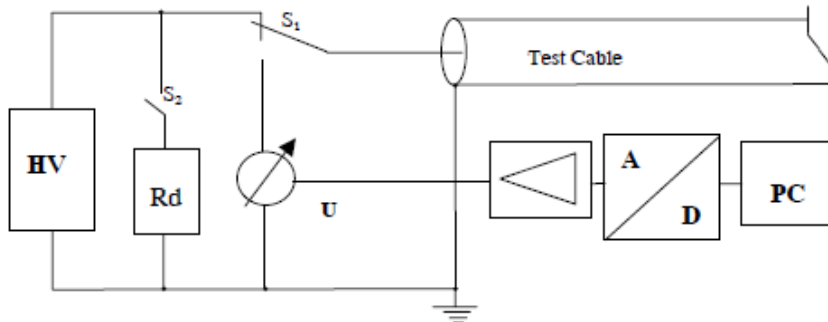
Figure 96 Block Diagram of the return voltage method [14]

The Cable Diagnostic System CD30 is for evaluation of the ageing degree and the damage condition of 1 kV to 30 kV PE and XLPE cables. The model CD31 is for oil-paper cables. The devices base upon measurement of **return voltages** at different charging voltages (Figure 96). The tested cable is charged with DC voltages (0.5, 1, 1.5,  $2U_0$ ) for 5 minutes (switch  $S_1$ ). Then, the high voltage source is turned off and the switch  $S_2$  closed for two seconds to discharge the cable capacitance over a resistor  $R_D$ . (Hagenuk)

After this time the return voltage is measured for 10 to 40 minutes, depending on the cable length. For that, the cable is connected to the high input impedance measurement receiver  $U$  (switch  $S_1$ ). The measured value of return voltage is digitized and forwarded to the PC. The maximum values of the return voltages are plotted as a function of the charging voltage. This relationship can be linear or non-linear. The linearity factor is calculated as the ratio between the maximum values of the return voltage at  $2U_0$  and  $U_0$  and used as an indicator of the ageing condition. The factor greater than 2 is considered as a non-linear response and signifies ageing of the cable and the factor 3 indicates a strongly aged cable. [14]

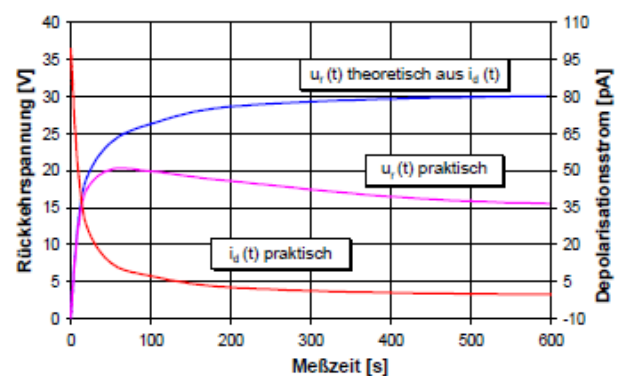
Bild 9: Vergleich zwischen der aus dem Depolarisationsstrom berechneten Rückkehrspannung und der praktisch erzielbaren Rückkehrspannung

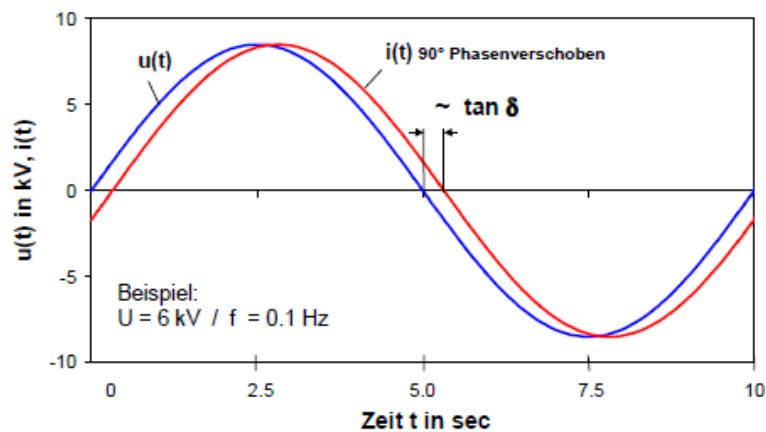
Figure 100, Tan Delta measurement [14]

The instrument PHG TD measures  $\tan \delta$  at different sine voltage levels maintained at 0.1 Hz. The  $\tan \delta$  at  $2U_0$  and the difference between  $2U_0$  and  $U_0$  values are used as diagnostic criteria. A  $\tan \delta$  value larger than  $1.2 \cdot 10^{-3}$  at  $2U_0$  or the difference of  $\tan \delta$  at  $2U_0$  and  $U_0$  larger than  $0.6 \cdot 10^{-3}$  signifies water tree deterioration. (Baur)

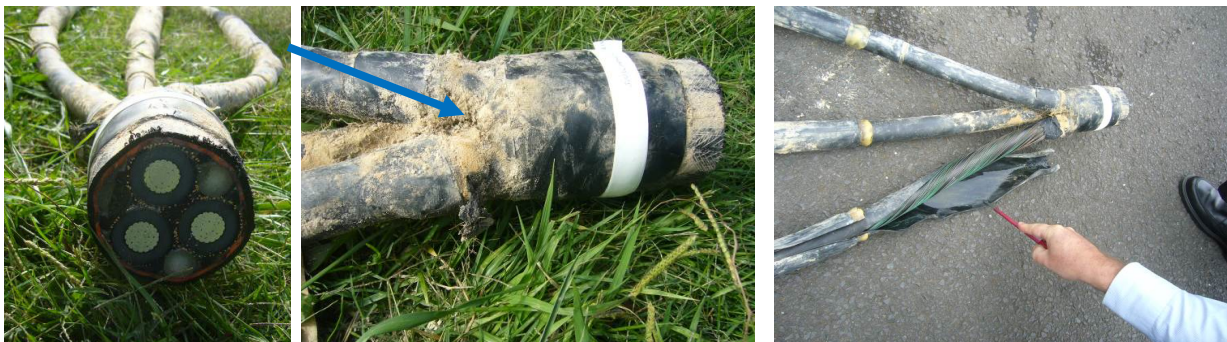
Damage was found at the joint, heat shrink tube; water under the outer protective heat shrink layer; strong corrosion on the cable sheath.

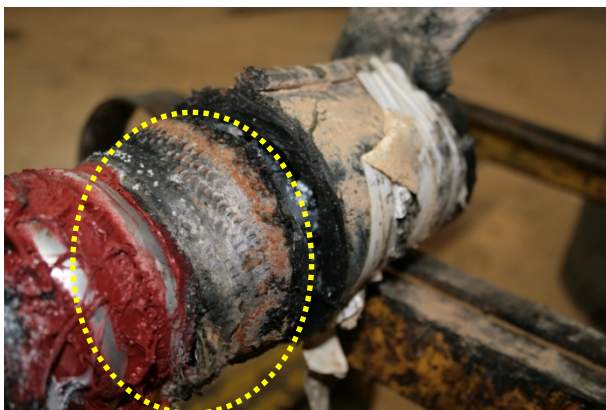
Fault point on L3 at Sumitomo

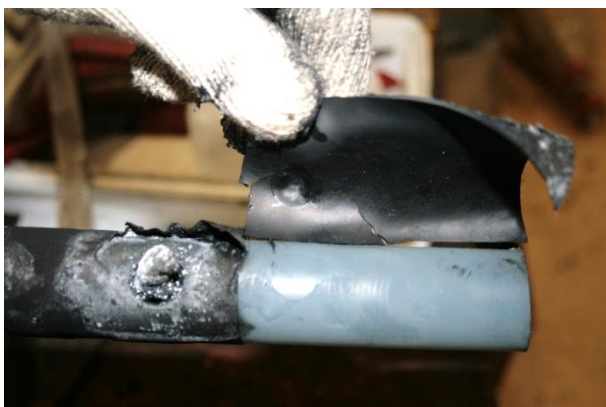
Water sign noted in insulation screen

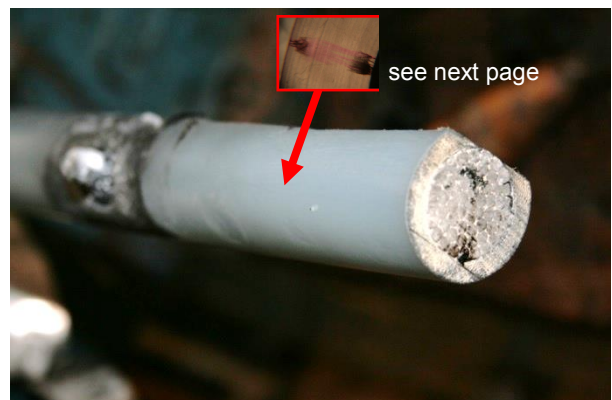
Suspected water tree developed near to fault point

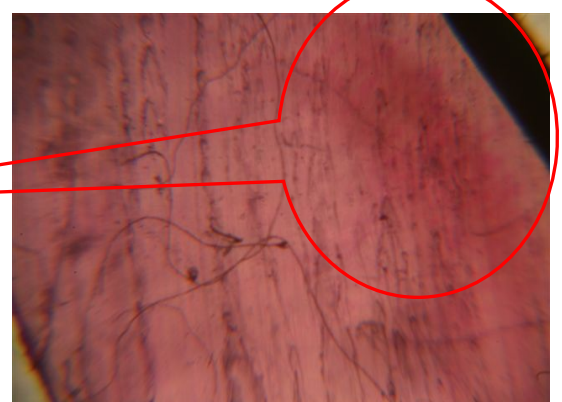
Spot #3 dissection, colored / microscope picture of severe water tree
