Locating a cable fault in the world's largest "clock tower"

Advanced Vision relies on BAUR cable test van

BAUR References

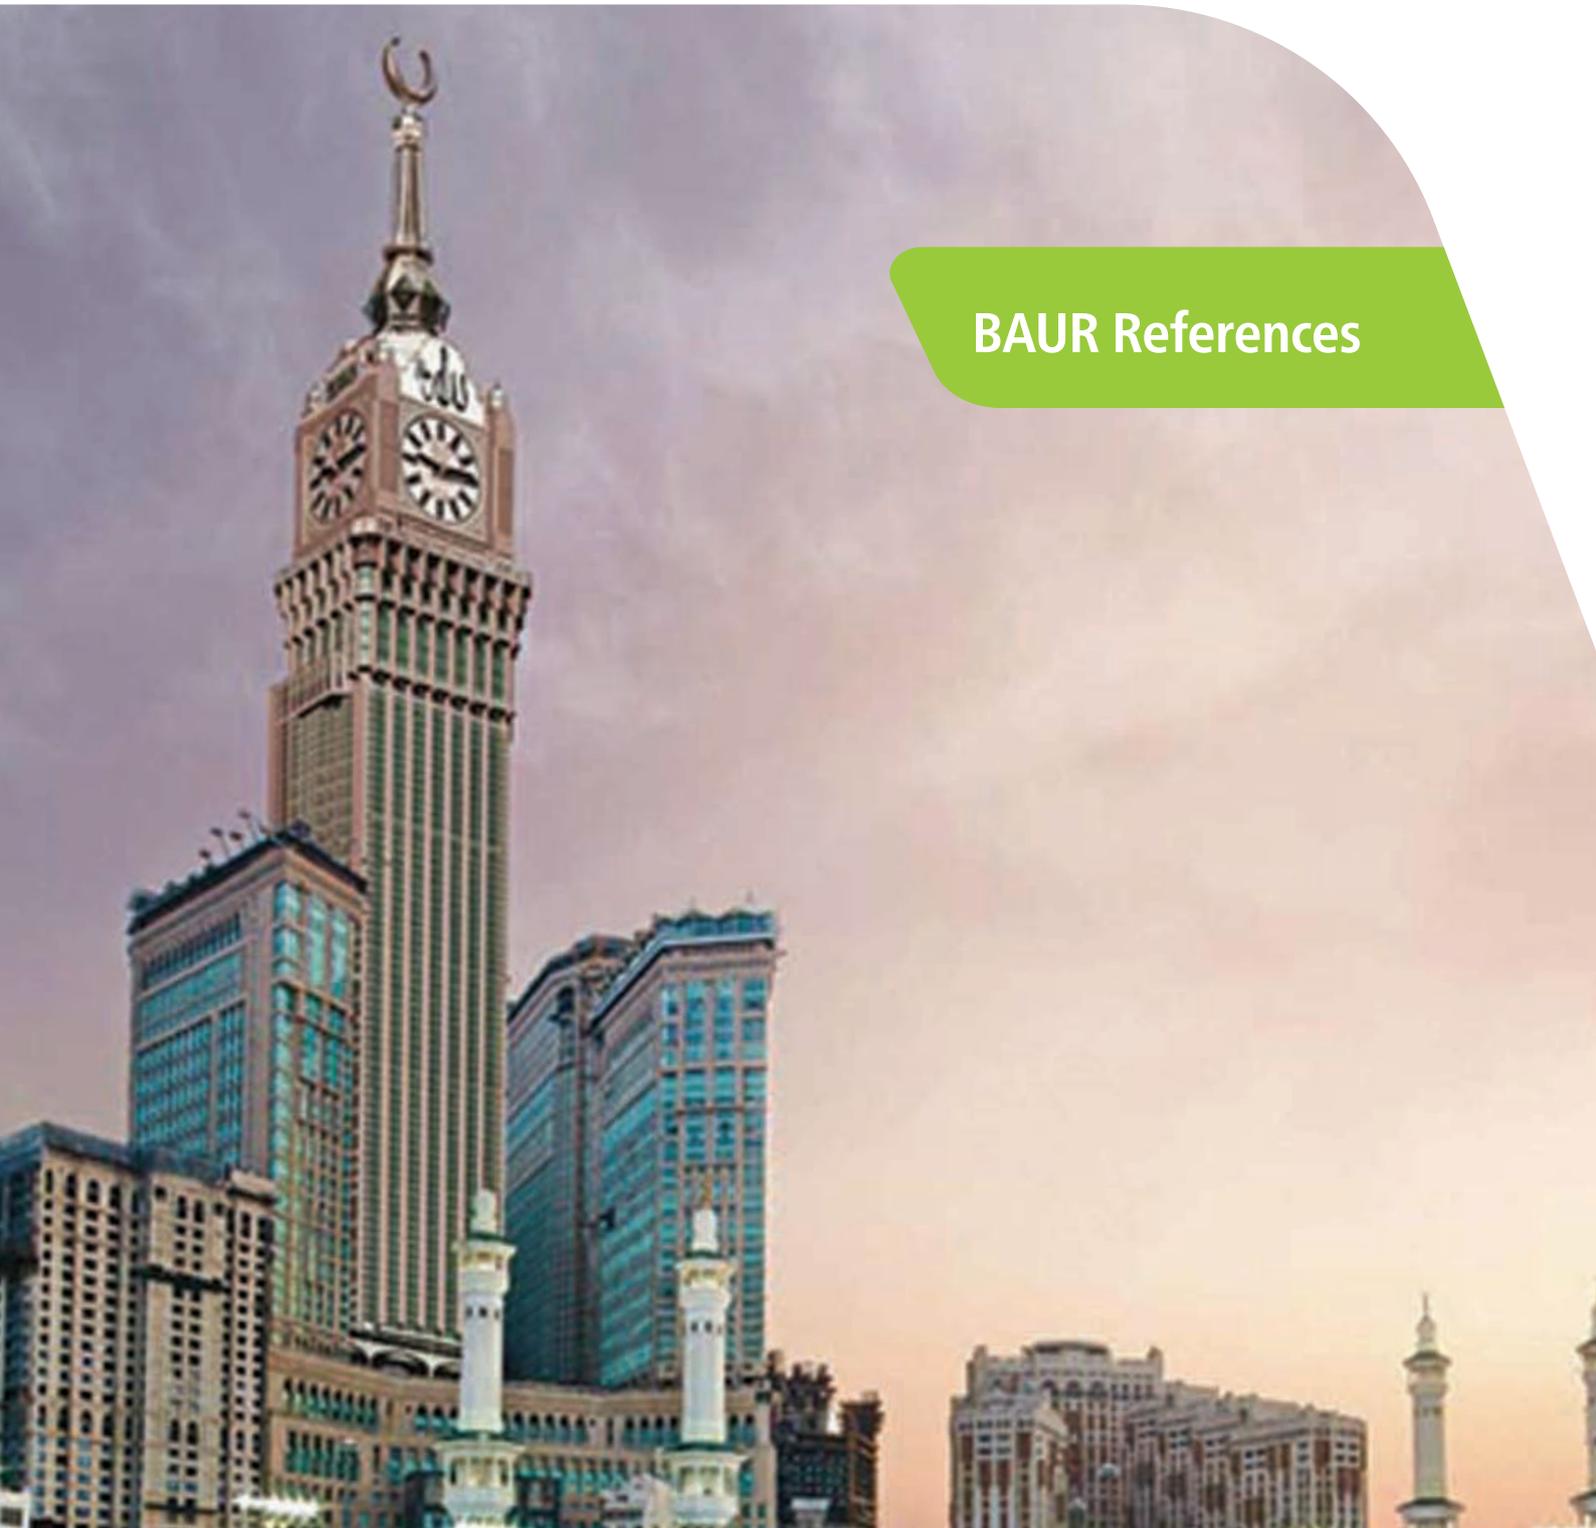
In this example, the fault was located using a cable test van (image). The preliminary location of the cable fault was identified using the IRG 3000 time domain reflectometer and pin-pointed with the SSG 1100 surge voltage generator in conjunction with an acoustic location method (description overleaf). This pinpointing was achieved using the UL 30 audio frequency receiver and BM 30 ground microphone on site.

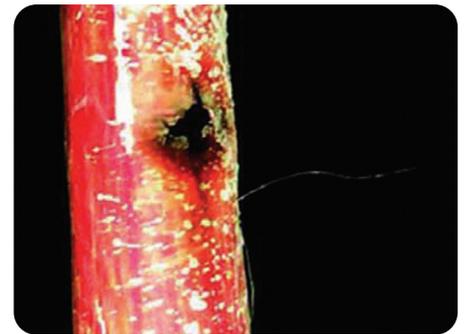
When a fault occurred in one of the medium-voltage cables in the tower in February 2013, it was up to the technical experts of Advanced Vision to find the fault as quickly as possible. Engineer Mamoun Al Shaher decided to use a BAUR cable test van to locate the fault. The van contains all the technical equipment needed to quickly identify and locate all typical types of defects, from short-circuits to broken cables.

Thanks to the exact mapping with the SSG 1100 surge voltage generator built into the cable test van and the BAUR

pin-pointing set (UL 30 and BM 30) it was possible to confirm the graphical evaluation just a few minutes later and the team from Advanced Vision was able to locate the fault immediately and rectify it quickly.
